Higher Learning – University Condition Assessment

Infra 2017 – December 5, 2017

Higher Learning – University Condition Assessment – University of Ottawa

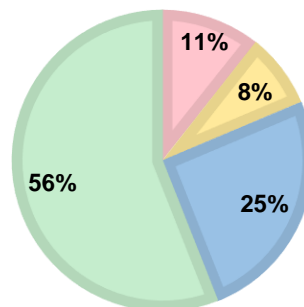
MAIN CAMPUS WATERMAINS OPERATION & MAINTENANCE RATING

- Generally in good condition (No leaks!)
- Various levels of tuberculation
 - PVC Sections range <5-15% reduction
 - Iron Sections (Ductile or Cast) range 5-35% reduction
- Slight surface damage and debris noted (not critical)
- Flushing/Cleaning and Relining of Iron Sections
 - Campus Wide program recommended

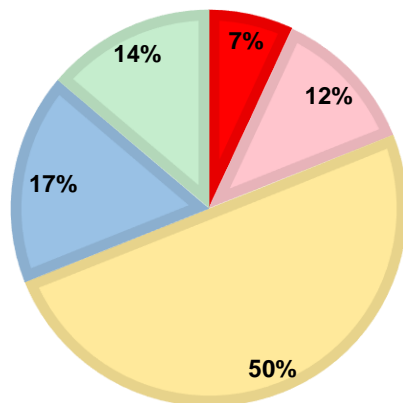
MAIN CAMPUS
SANITARY SEWERS
STRUCTURAL RATING

- Typical observations
 - Cracks, debris, displaced joints, surface damage, attached deposits, sags, visible rebar
- Materials
 - Concrete, PVC, Vitrified clay, asbestos cement
