In-Line Condition Assessment of Small Diameter Pipes While They Remain in Service

Presented by:
William (Bill) Jappy
Canadian Business Development Manager
Wachs Water Services
bjappy@wachsws.com

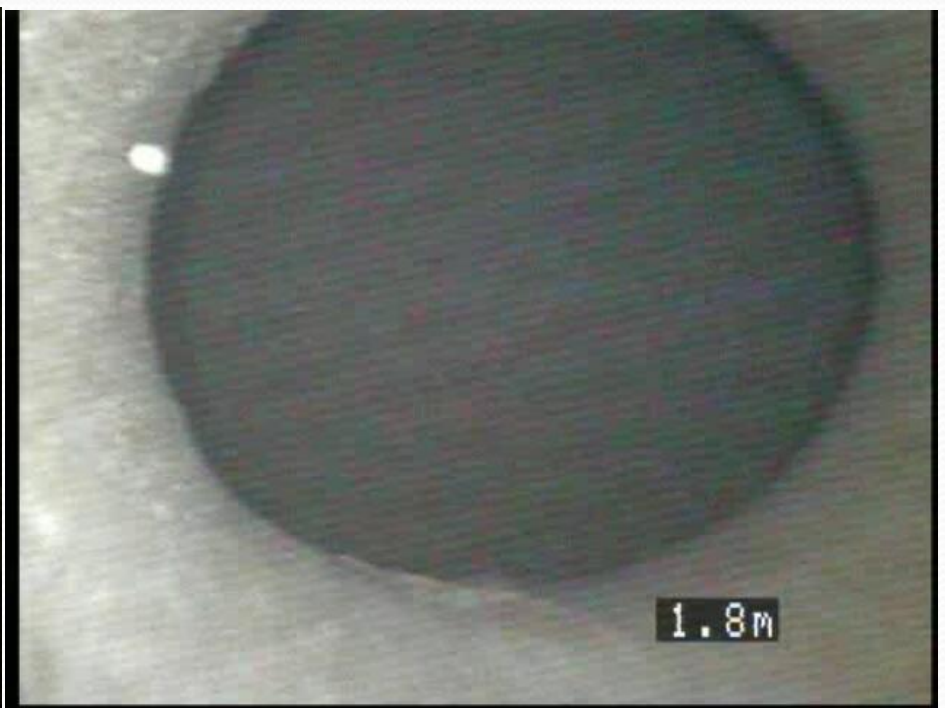
Identification and location (GPS) of undocumented valve

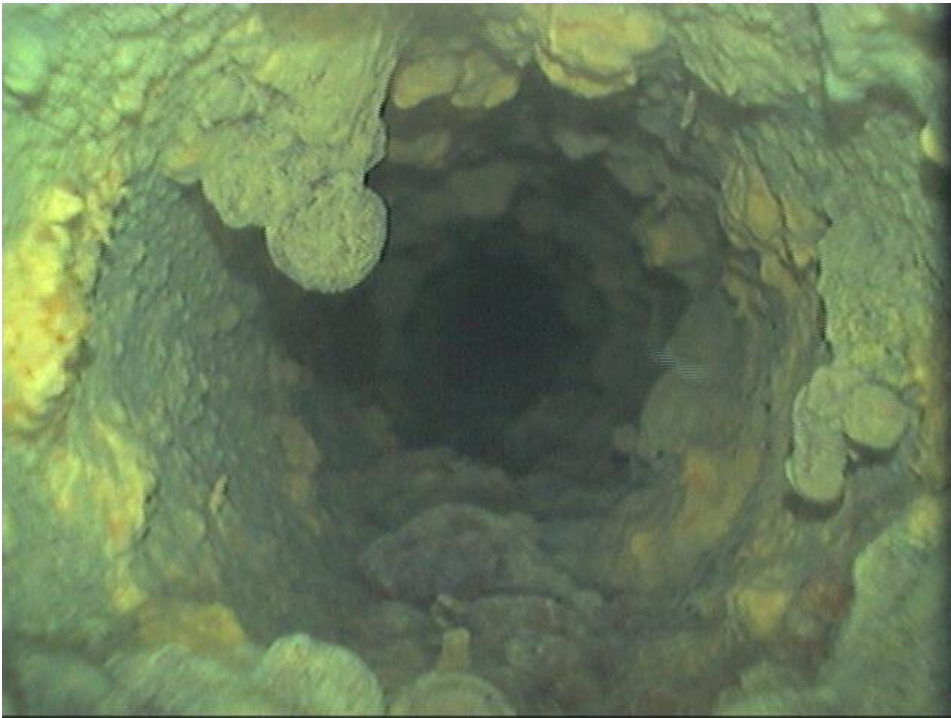
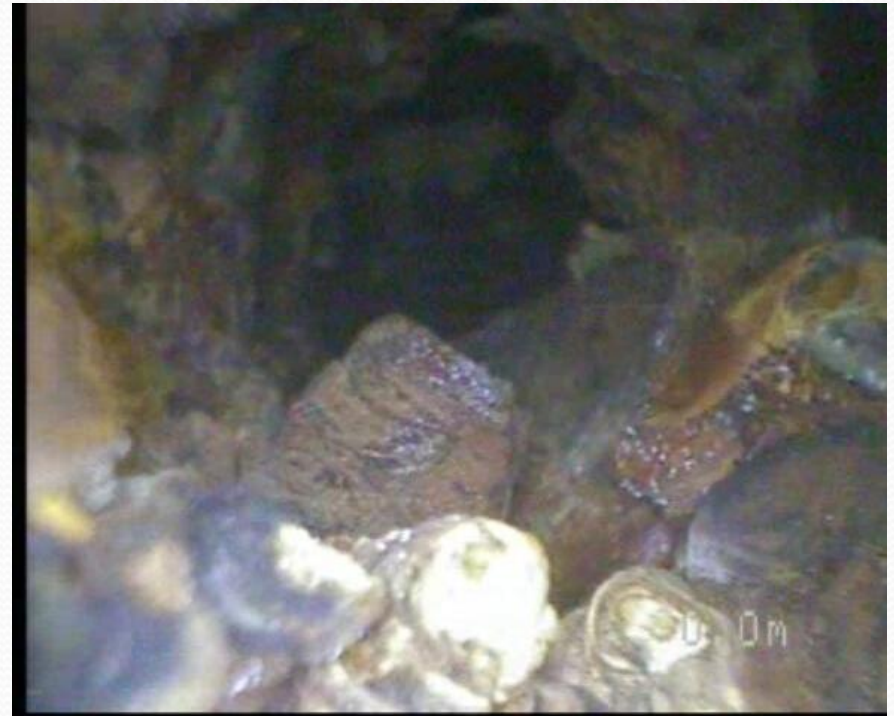
Severe flow restrictions due to late stages of tuberculation build up.
Leads to pressure loss.

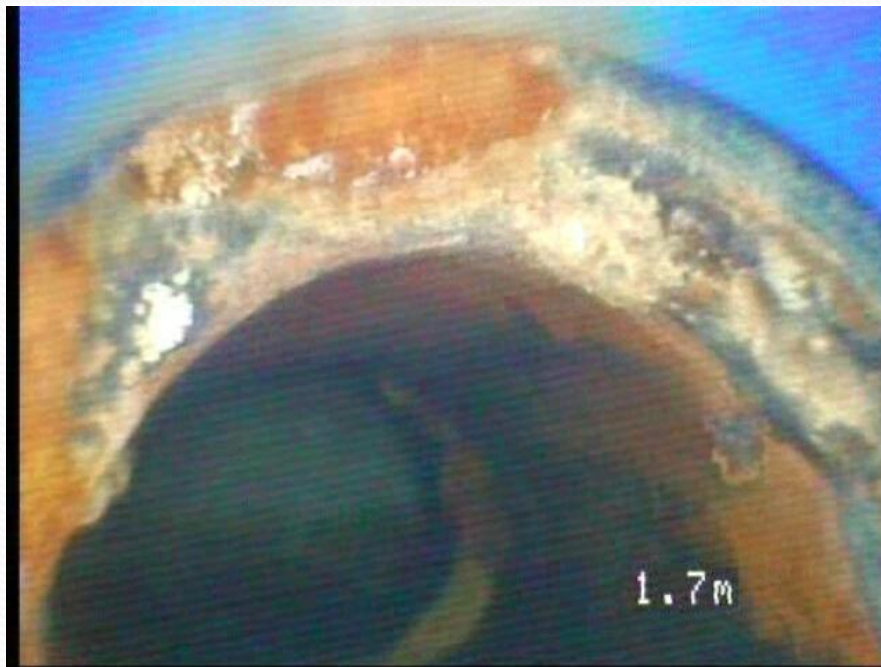
Corrosion at cast iron pipe joint

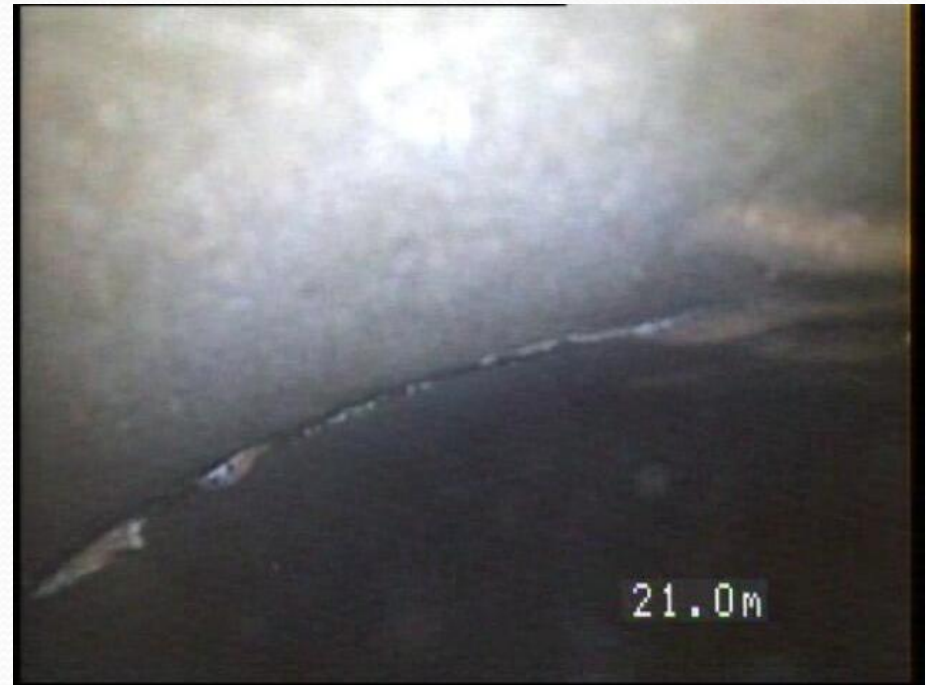
Clean joint verification

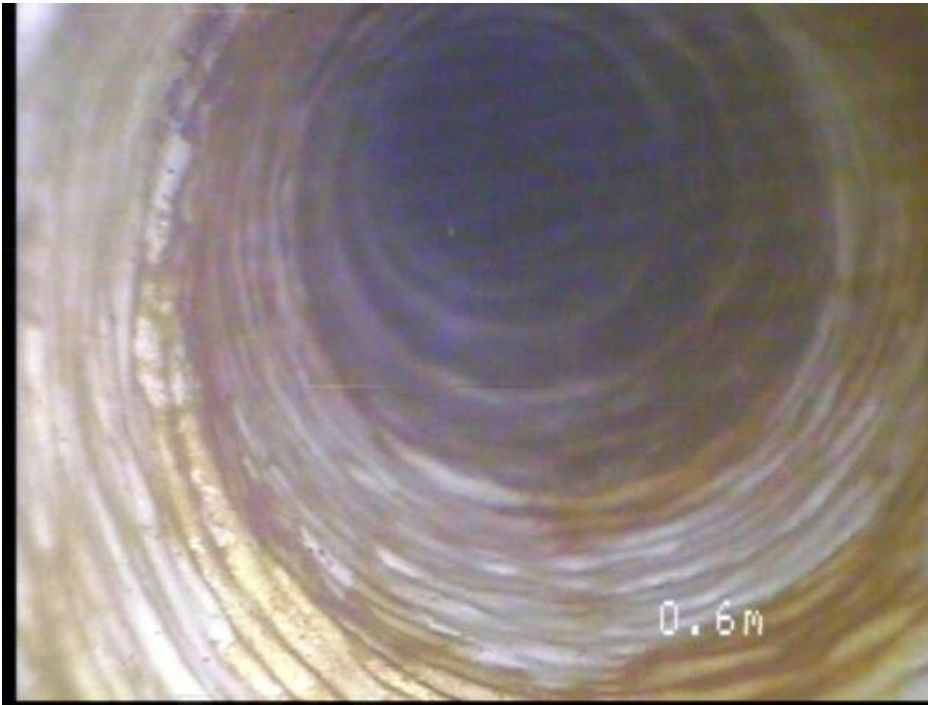
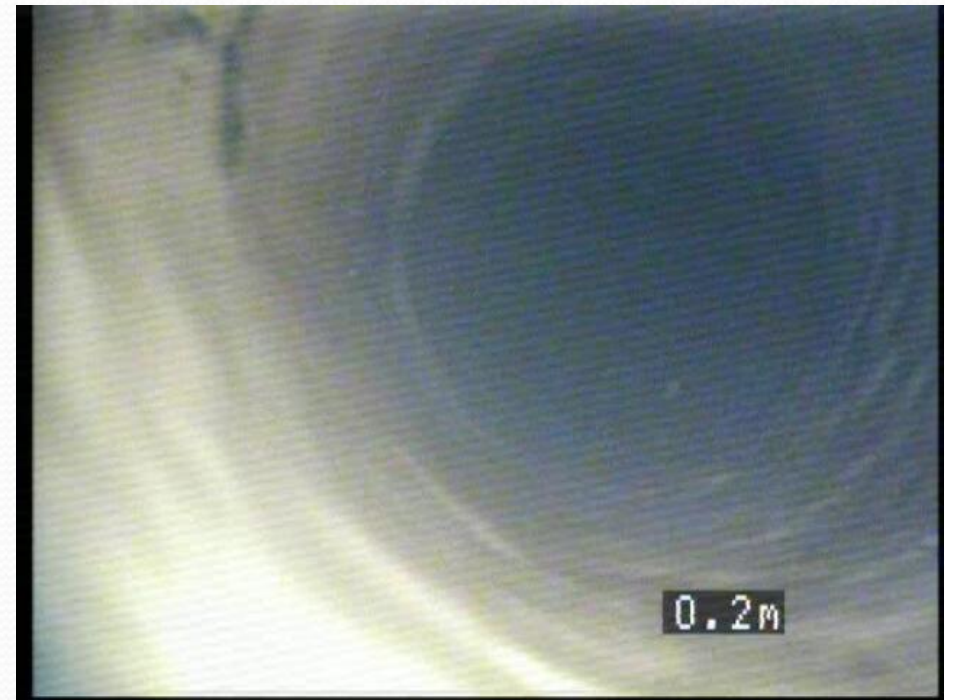
Post liner quality inspection and verification.
Prioritization of pipelines to rehabilitate.

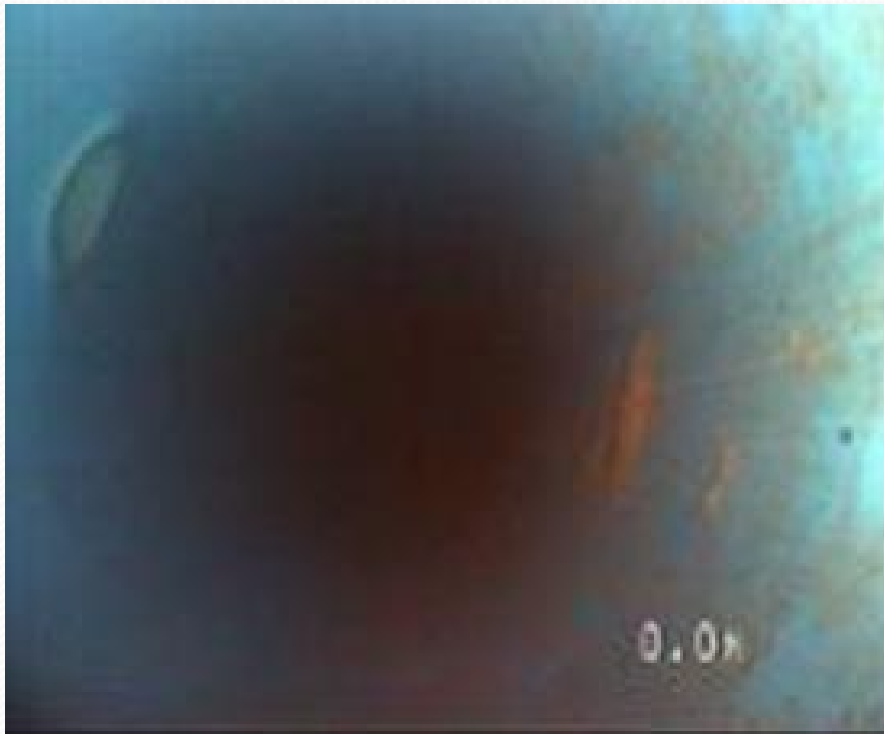
Tap located and confirmed not to be a leak

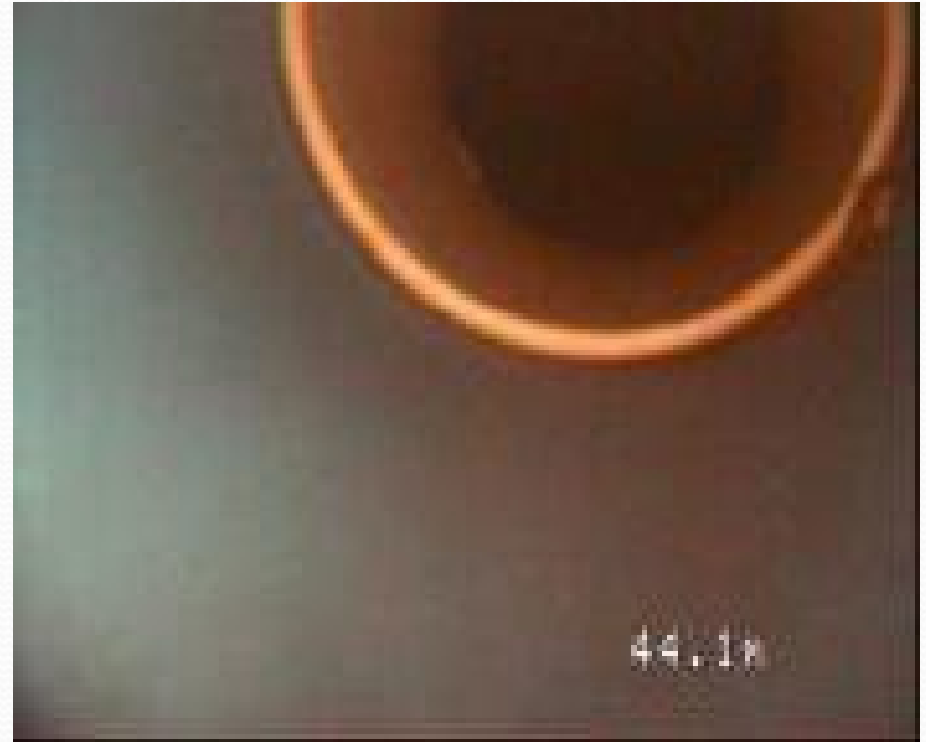
Change of material confirmed not to be a leak as identified by correlation

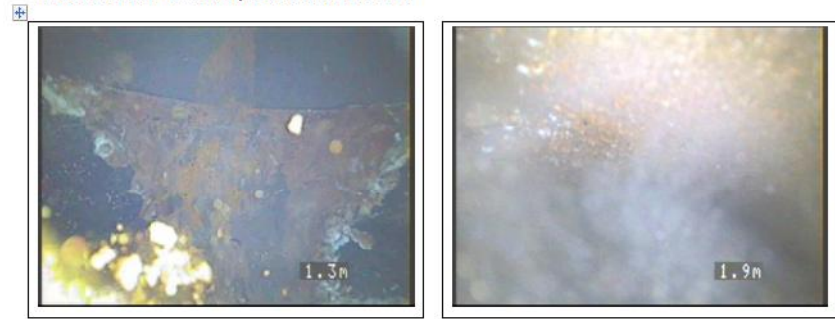
Under Pressure CCTV Inspection DIRECTION 1:

Main inspected in one direction.
Heavy debris and moderate build up in entry point (shown above). Main inspected to 23 metres approximately and is in good general condition, but with areas of slight loose debris and moderate to heavy loose sediment in places.

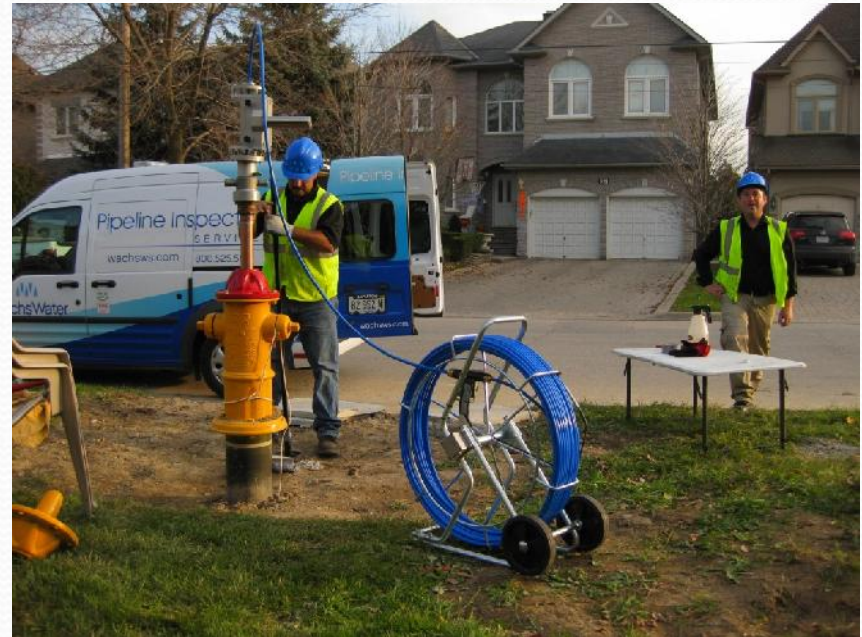
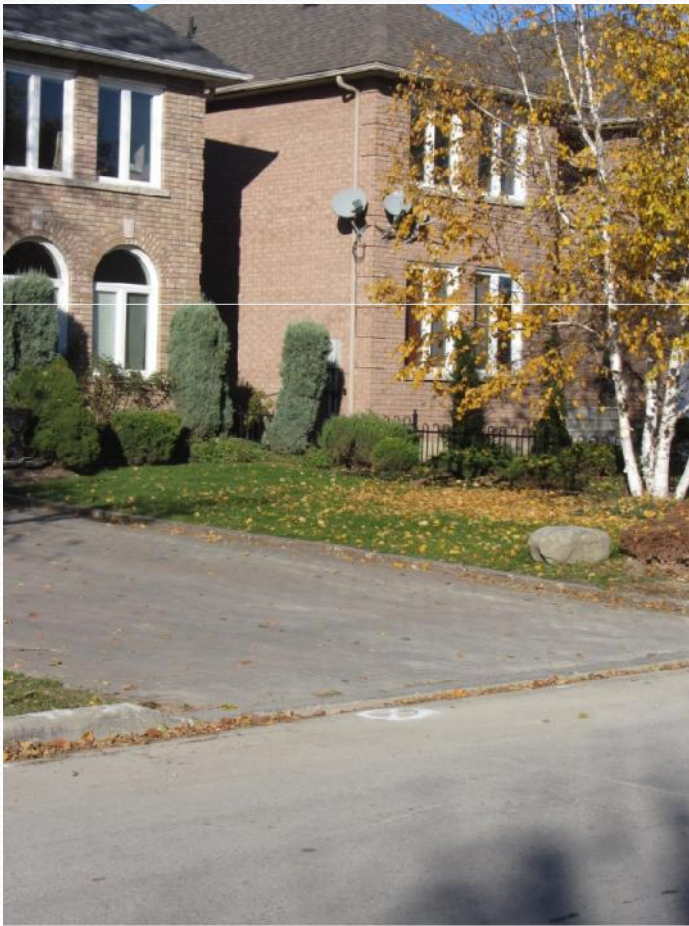
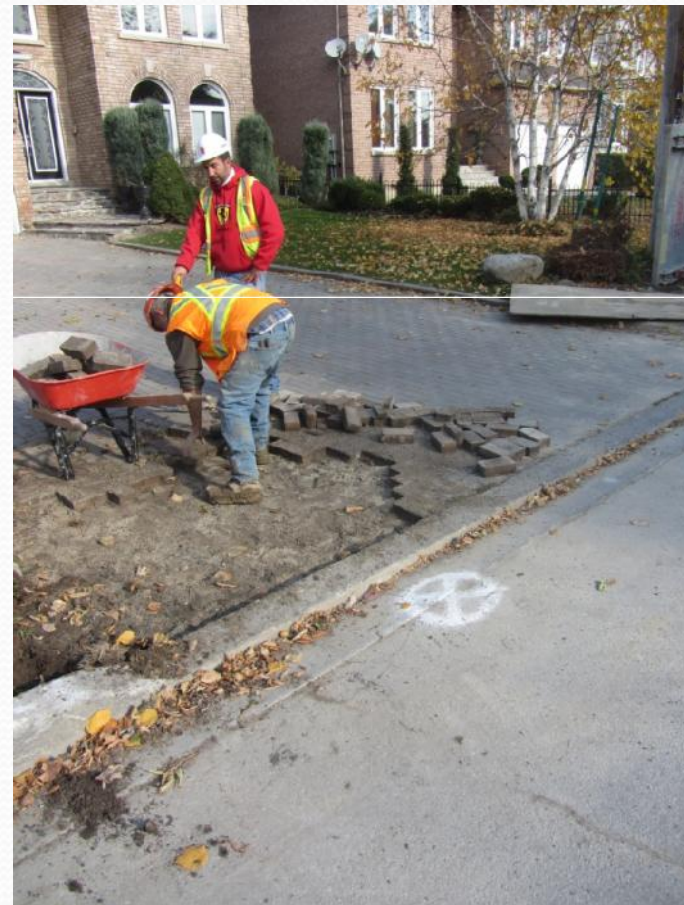
Leak 1, 2m Depth, 75 PSI, Located Under Driveway, Sonde Location within 4 Inches

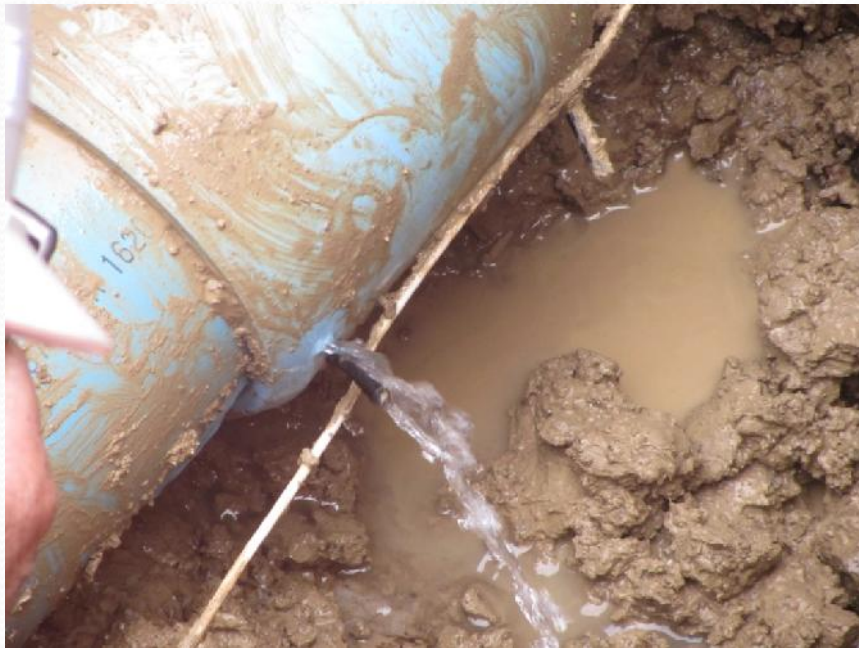
Confirmed Leak

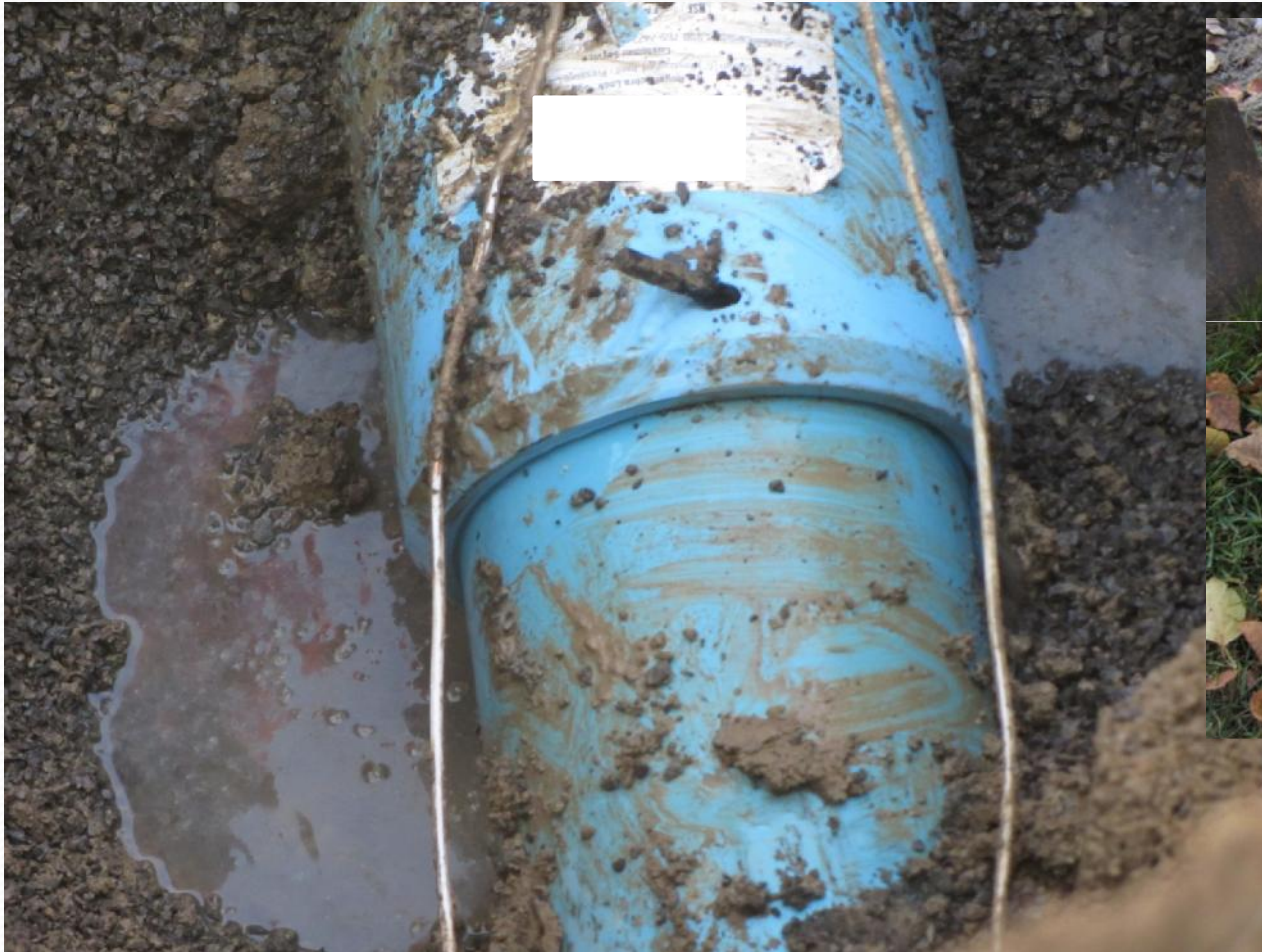
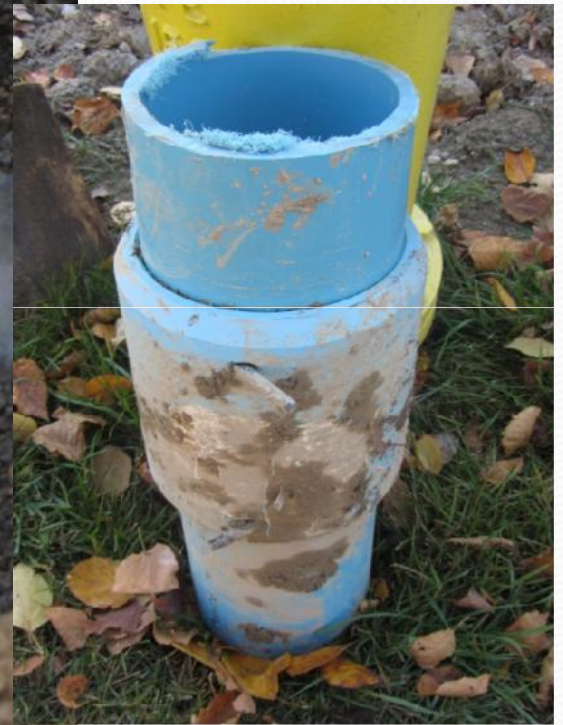
Leak 2, 2m Depth, 75 PSI,
Approximately 20 ft from Leak 1, Sonde
location within 6 inches

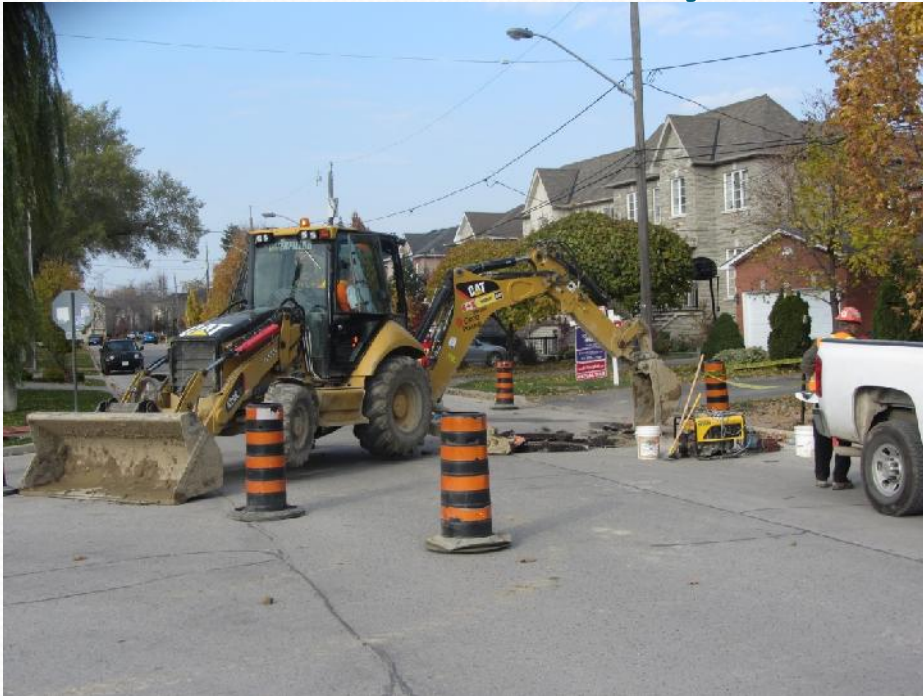
Leak 3, 3m Depth, 75 PSI, Middle of Busy Intersection

Sonde accurately identified location of leak on busy intersection near vault.

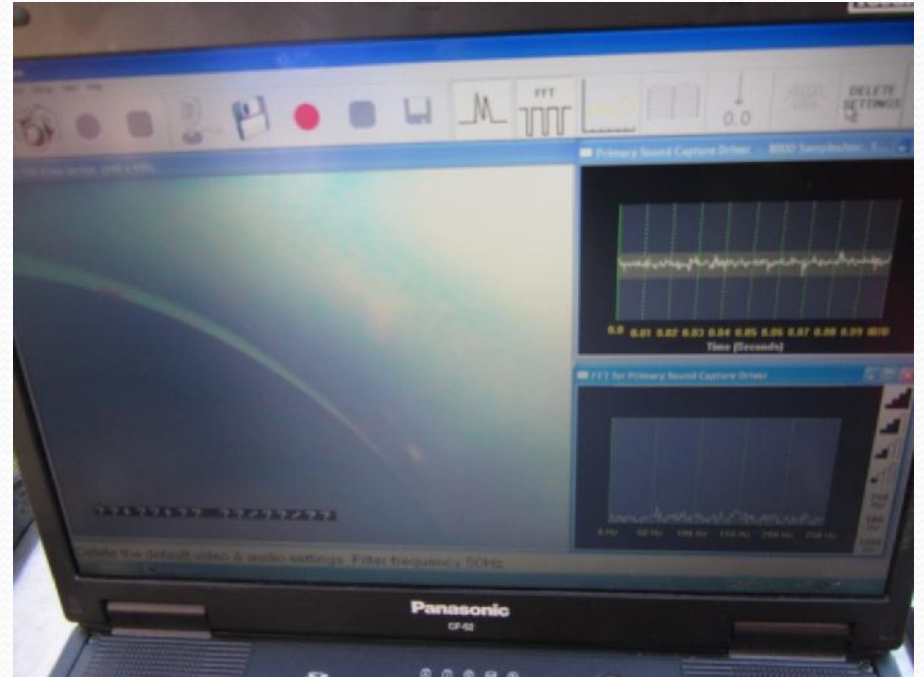
Leak detected by acoustic sensor (right graphs) and visual confirmation at joint via CCTV (left).
